**Flood Control Project Maintenance  
Levee Inspections**  
**LMA District Cover Sheet**  
**Spring 2019 Levee Inspection Results**

**Reclamation District No. 1500 Sutter Basin**

**Spring 2019 Levee Inspection Results**

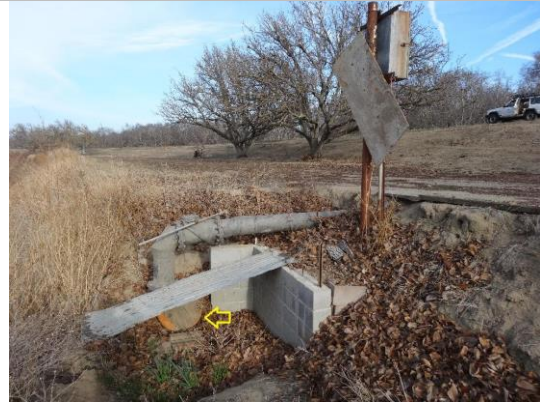
Photo 1 of 3 : UCIP\_SP\_2019\_28183\_51845.jpg

Comment Code						
Inspector Comment						
FS_ID:28183 DS_ID:20032 EP_NO: 1566A Repair Type: Non-Urgent Crossing Status: Found UCIP Comments: - soil erosion around headwall on waterside.- pump was removed.- overhead powerline. FIELD_STRUCT_DESC: *REPLACEMENT CROSSING* 10-inch coated steel irrigation discharge pipe through the levee, 5 feet below the crown. Pump and switch panel on the waterside (WS) berm. Service pole on WS shoulder. Siphon breaker on the landside (LS) slope. 3-foot by 4-foot concrete distribution box at the LS toe. (Replacement of an existing pipeline through the levee authorized under Permit No. 1566-A, 1980 - Ralph White Jr.). [Additional Reference(s): DWR Levee Log, 2005. USACE Sacramento O&M Manual 128, March 1960, (HLM 0.30), 8-inch pipe referenced]. FS Date: 1/9/2014

WS view: concrete blocks headwall and pump on river bank. Pump has been removed (marked). Surface erosion around headwall.

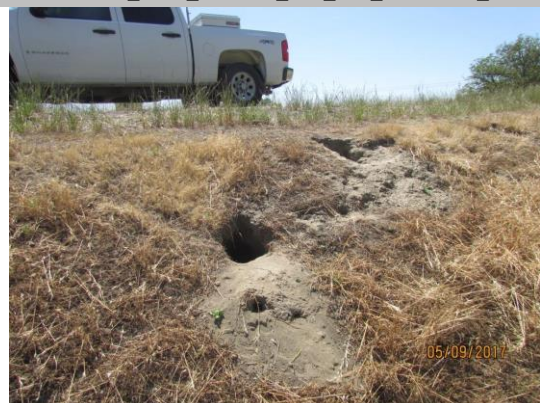
Photo 1 of 1 : SP\_2019\_RD1500\_189\_149\_20190304\_00078.jpg

View of rodent holes on landside slope. Spring 2017.

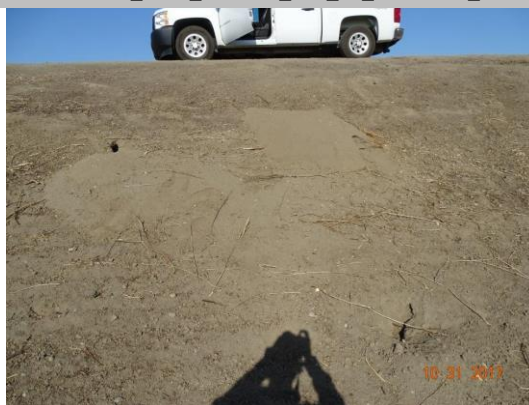
Photo 2 of 2 : SP\_2019\_RD1500\_189\_99\_20190304\_00048.jpg

View of holes and mounds on landside slope. Fall 2017.

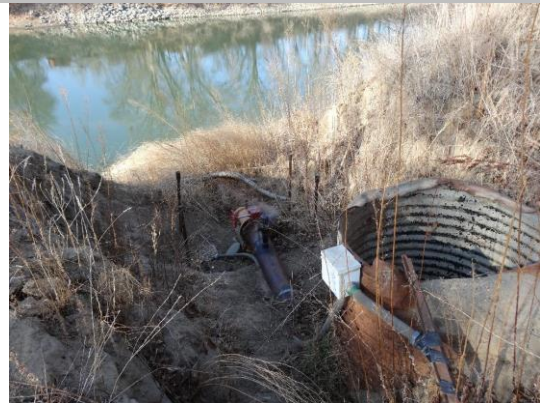
Photo 1 of 3 : UCIP\_SP\_2019\_28263\_51965.jpg

Comment Code						
Inspector Comment						
FS_ID:28263 DS_ID:20034 EP_NO: 16146 Repair Type: Non-Urgent Crossing Status: Found UCIP Comments: - pump removed- overhead powerline- pile structure abandoned- levee slope erosion due to leaky siphon breaker on landside. FIELD_STRUCT_DESC: *REPLACEMENT CROSSING* 12-inch steel irrigation discharge pipe through the levee, 12 feet below the crown. Pump mounted on the riverbank. Butterfly valve on the waterside (WS). Power pole with one anchor on the WS slope. Pipe discharges into a 5-foot by 5-foot damaged concrete distribution box across the irrigation ditch on the landside (LS). Electrical conduit through the levee. (Cat. I - Furlan). (Abandonment-in-place of an existing pipe and replacement of approximately 70 feet of 12-inch irrigation discharge pipe authorized under Permit No. 16146, 1993 - Antonio Furlan and Joe Schreiner). [Additional Reference(s): DWR Levee Log, 2005. USACE Sacramento O&M Manual 128, March 1960, (HLM 1.96)]. FS Date: 1/9/2014

WS view: Pump (removed and plywood plated), pipe, and gate valve in CMP riser on river bank.

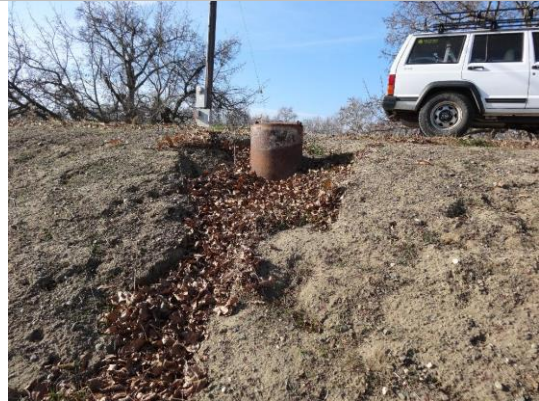
Photo 2 of 3 : UCIP\_SP\_2019\_28263\_51964.jpg

LS view: siphon breaker in CMP riser. Levee slope erosion due to leaky siphon breaker.

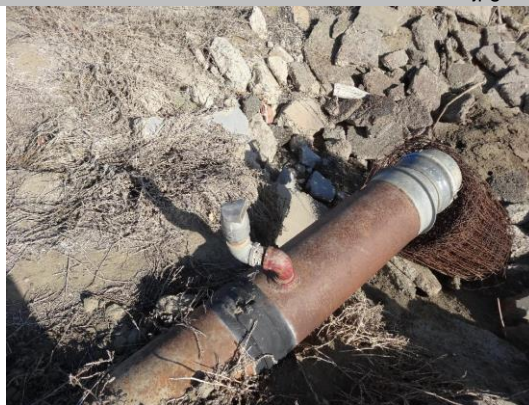
Photo 3 of 3 : UCIP\_SP\_2019\_28264\_51969.jpg

LS view: plugged discharge pipe with air vent across irrigation ditch on landside.

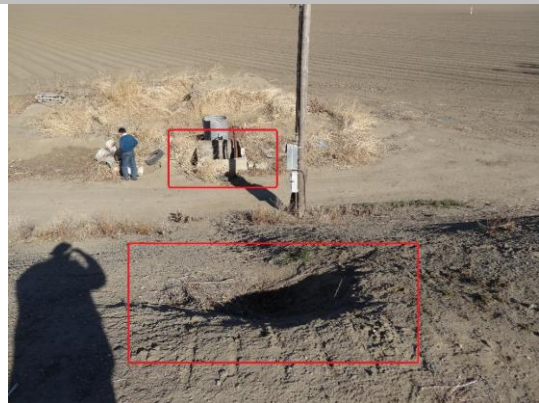
Photo 2 of 3 : UCIP\_SP\_2019\_28913\_53183.jpg

LS view: depression on landside levee slope around siphon breaker due to leakage. Concrete distribution box (top) on levee toe.

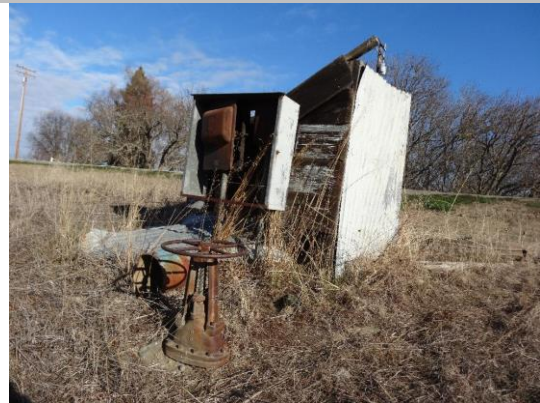
Photo 1 of 3 : UCIP\_SP\_2019\_28923\_53202.jpg

WS view: dilapidated and abandoned CM pump house on berm. Pipe and gate valve also on berm.

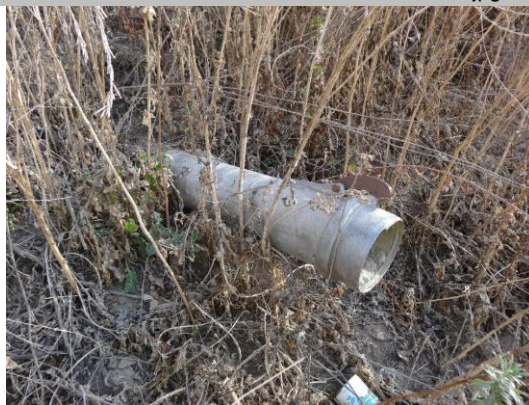
Photo 2 of 3 : UCIP\_SP\_2019\_28323\_52124.jpg

WS view: abandoned steel pipe exposed on river bank.

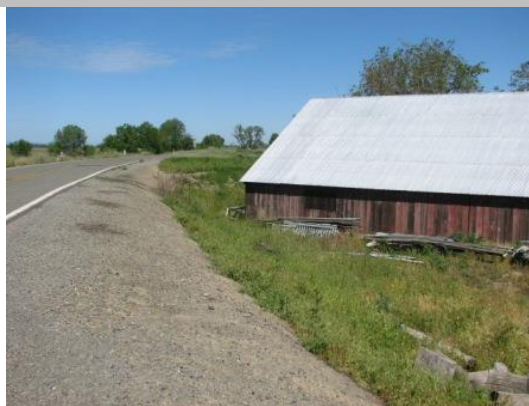
Photo 1 of 1 : SP\_2019\_RD1500\_189\_18\_20190304\_00008.jpg

The corner of the building has encroached into the toe.

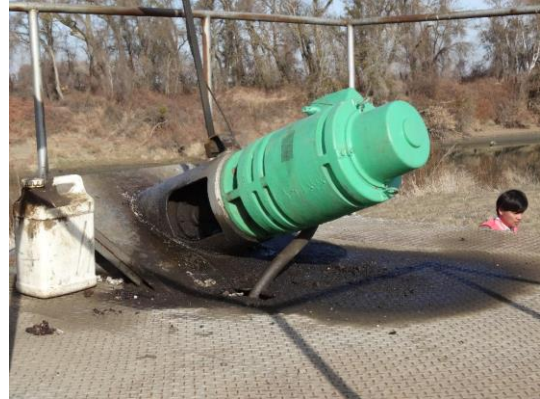
Photo 1 of 3 : UCIP\_SP\_2019\_28364\_52174.jpg

WS view: slant pump on steel platform on levee berm. Excessive oil leak from the pump.

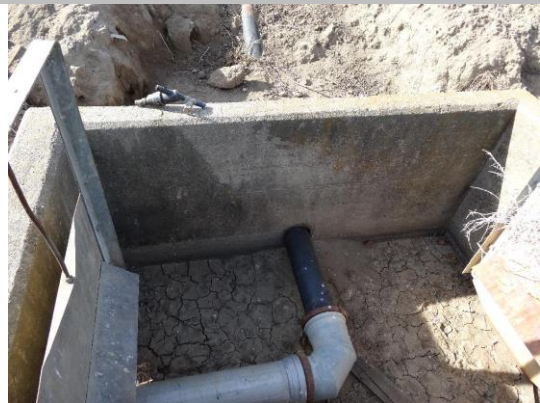
Photo 3 of 3 : UCIP\_SP\_2019\_50198\_52221.jpg

LS view: concrete distribution box on levee toe. Exposed pipe and depression (top) visible on levee slope.

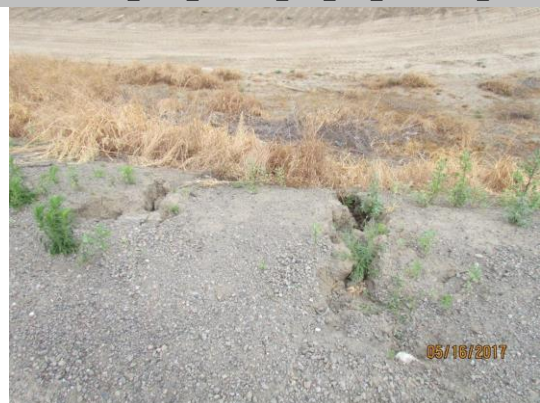
Photo 1 of 1 : SP\_2019\_RD1500\_189\_116\_20190304\_00058.jpg

View of erosion on landside slope. Spring 2017.

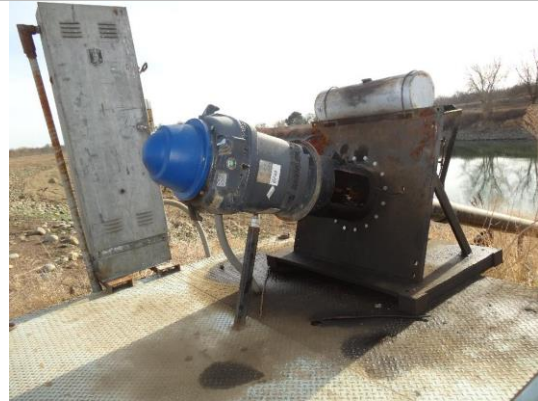
Photo 2 of 3 : UCIP\_SP\_2019\_28486\_52460.jpg

WS view: oil leaking slant pump on steel platform.

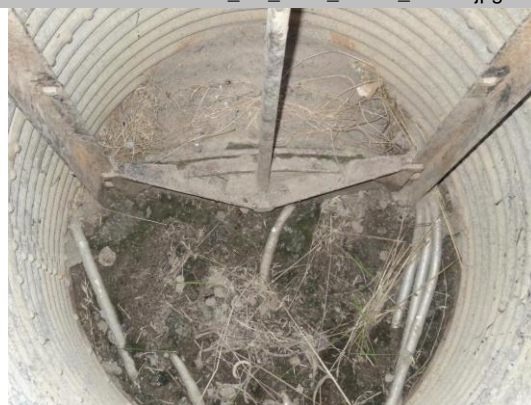
Photo 2 of 3 : UCIP\_SP\_2019\_28489\_52478.jpg

WS view: cleaning and clearing require around slide gate in CMP riser.

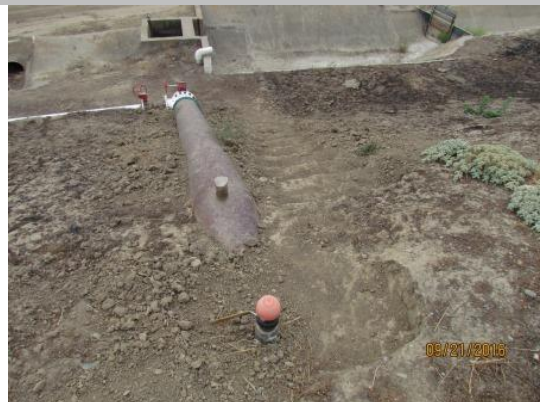
Photo 1 of 1 : SP\_2019\_RD1500\_189\_117\_20190304\_00059.jpg

View of stairs dug on landside levee slope. Fall 2016.

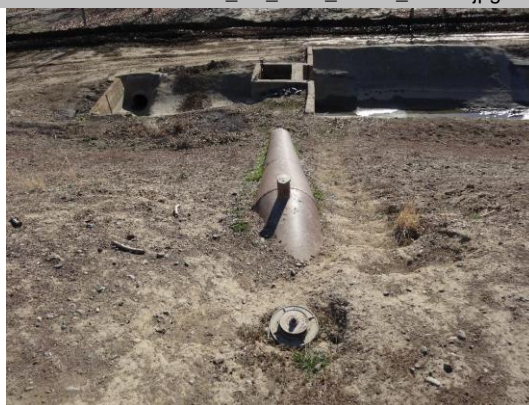
Photo 2 of 3 : UCIP\_SP\_2019\_28490\_52484.jpg

LS view: siphon breaker (bottom) without protection, exposed pipe on levee slope, and distribution box on levee toe.

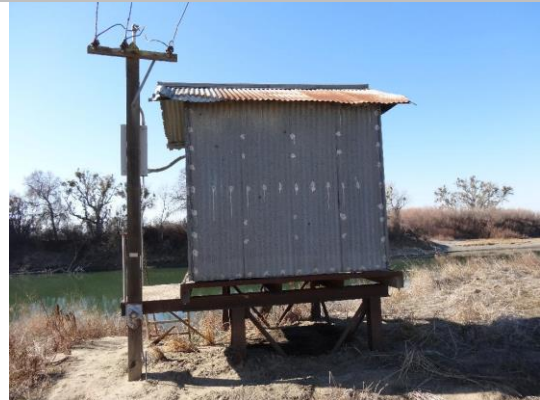
Photo 1 of 3 : UCIP\_SP\_2019\_28506\_52523.jpg

WS view: slant pump in CM shed on levee berm. Oil leaks from the pump.

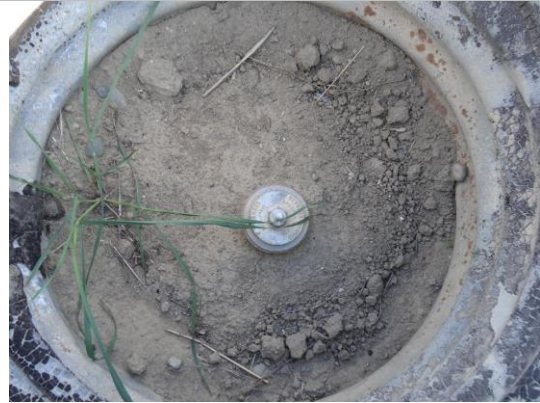
Photo 3 of 3 : UCIP\_SP\_2019\_28527\_52566.jpg

LS view: obstructed siphon breaker in CMP riser on levee slope.

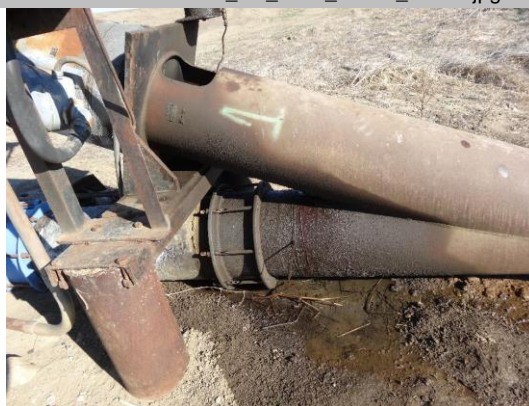
Photo 2 of 3 : UCIP\_SP\_2019\_28528\_52575.jpg

WS view: leaky inlet pipe near pump platform.

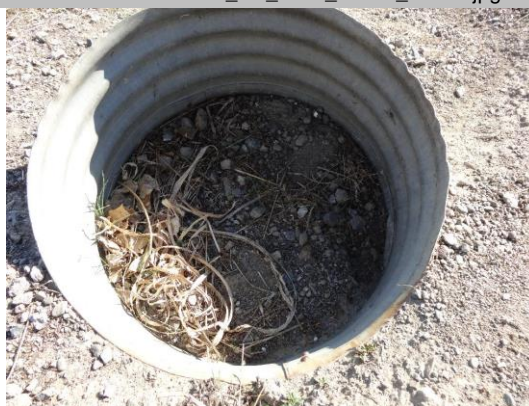
Photo 3 of 3 : UCIP\_SP\_2019\_28631\_52721.jpg

LS view: obstructed siphon breaker in CMP riser on levee slope.

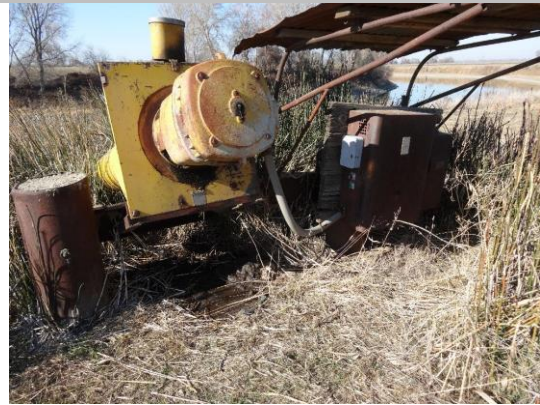
Photo 1 of 3 : UCIP\_SP\_2019\_50193\_51827.jpg

WS view: leaky slant pump on levee berm.

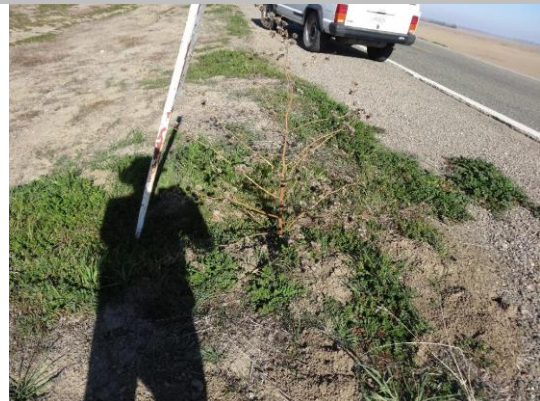
Photo 3 of 3 : UCIP\_SP\_2019\_50193\_51825.jpg

WS view: excessive vegetation along pipe alignment on levee slope.

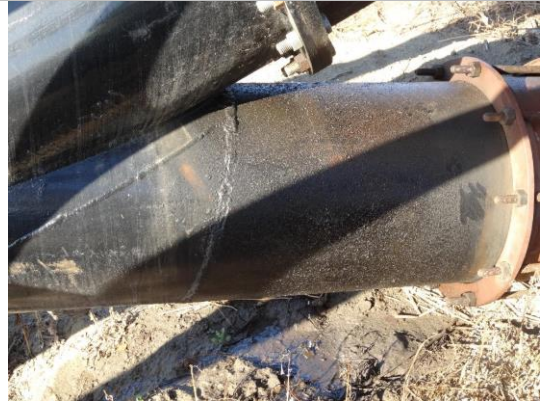
Photo 3 of 3 : UCIP\_SP\_2019\_28953\_53254.jpg

WS view: oil and water leaking from pipe near pump.

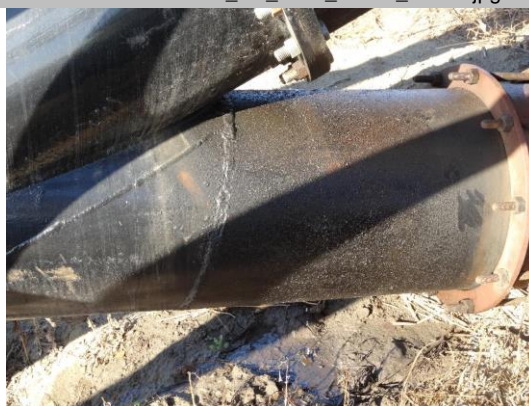
Photo 3 of 3 : UCIP\_SP\_2019\_28952\_53247.jpg

WS view: oil and water leakage from pipe near pump.

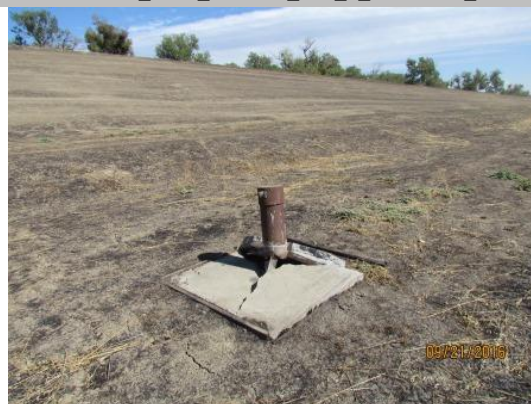
Photo 1 of 3 : SP\_2019\_RD1500\_190\_4\_20190304\_00001.jpg

View of underseepage relief well with destroyed concrete pad as well as PVC pipes. Fall 2016.
